Southern Waters Sludge Holding Tanks suffer from excessive corrosion due nature of the liquor held, environment, location in some cases and the H₂S gas that sits in pockets above the held liquor.

Working closely with Resimac, MKE Engineering were asked to provide a corrosion protective system for the Sludge Holding Tank No 2 at Newhaven. This bespoke durable solvent free system comprises of an epoxy coating with cold cured corrosion resistant metal rebuilding materials.

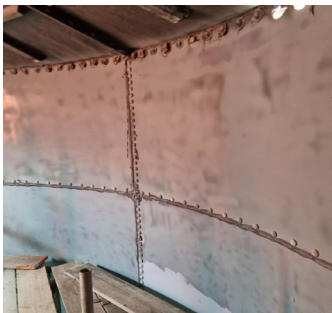
The tank was scaffolded in three lifts to achieve full access from the floor to roof sections. All the tank walls were abrasive blasted to achieve a Sa2.5 level of surface cleanliness with a circa 50-micron angular profile. It is this cleaning and preparation of the parent material that is key to the warranty of the coating. All dust and debris were removed before the coating applications commenced. The Holed sections of the tank were prepared, and plate bonded utilising 5mm blasted steel plates and Resimetal 302 as the bonding agent. Areas at the tank – roof interface were also addressed in the same way.

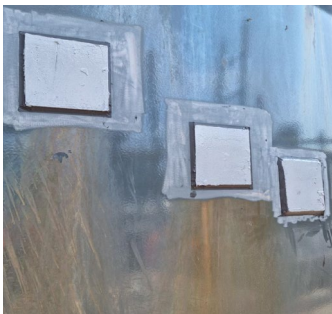
The tank was coated with light grey Resichem 50I CRXL to an average thickness of 350 microns. An extra coat was applied to all vulnerable areas in a contrasting colour of 50I CRXL and was applied once the first coat is stable enough to accept another layer.

Once the first coat of the 50I CRXL was cured sufficiently to accept a further layer, the final coat was applied at the same average thickness as the first coat at an average 350 microns.

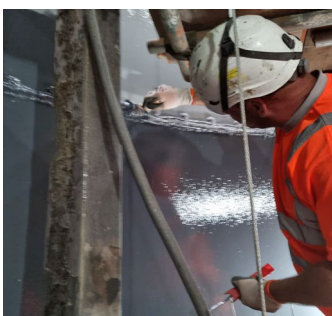
This Resimac corrosion protective system was installed by our trained and approved contractors. This application was carried out in full compliance with the Resimac Technical Datasheets, Application Guide lines and Method Statement. This complicated system is robust and integral to achieve the corrosion protection for the material design life of 10-15 years.

Areas that were plated will resist the corrosive effects of the process and will remain robust. Jointed areas of the tank from the point of manufacture were built with a mastic material sealing the joints. These joints were difficult to inspect the integrity. However, the extra coating that was applied to these areas will add longevity to these jointed locations.

The wall – roof interface had suffered severe corrosive attack and places were installed to aid the integrity of these areas. These works undertaken by all personal were completed safely and in full compliance with the local laws and regulatory standards.
